McCORMICK & BAXTER OR

KEVIN PARRETT, OREGON DEPARTMENT OF ENVIRONMENTAL QUALITY

McCormick & Baxter Site Overview

Sediment Remedy Effectiveness Retrospective Workshop

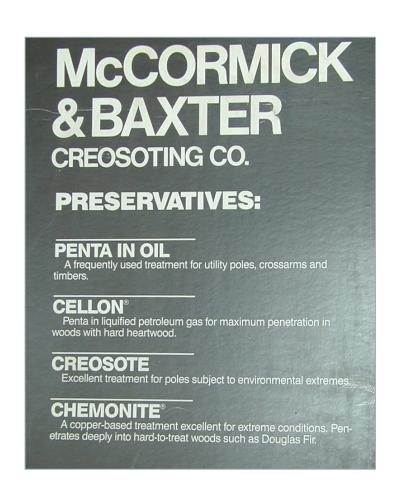
- ROD Operable Units (1996)
 - Sediment, groundwater, and soil
- Sediment COCs
 - cPAHs (2 mg/kg), dioxins/furans (80 ng/kg), arsenic (12 mg/kg), PCP (100 mg/kg), AWQCs, and bioassays
- Human Health
 - Direct contact with contaminated sediments
 - Consumption of contaminated fish and crayfish
- Ecological
 - Direct contact of aquatic organisms with contaminated sediments

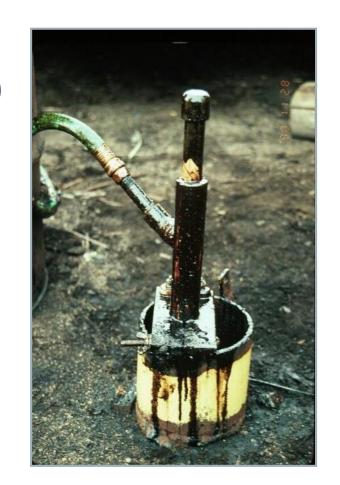
- 1990 to 2011: Creosote extraction (6,600 gallons)
- 1990: Soil hot spot removal (34,000 tons)
- 2003: Groundwater barrier wall (18 acres)
- 2004/2005: Sediment cap (23 acres)
- 2005: Soil cap (15 acres impermeable, 25 acres permeable)

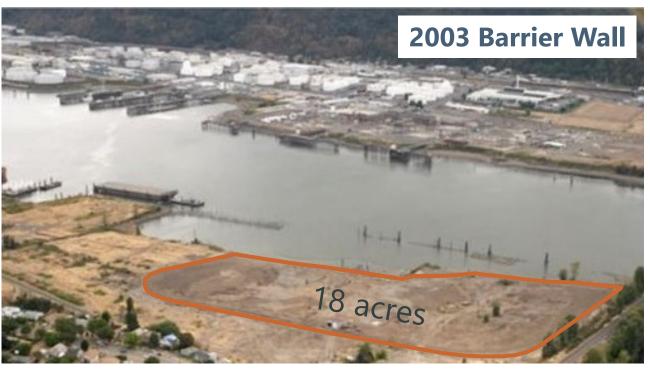
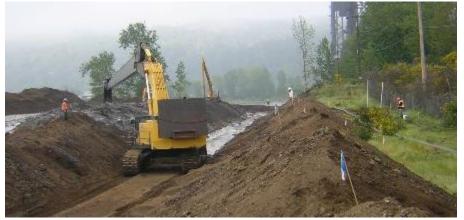
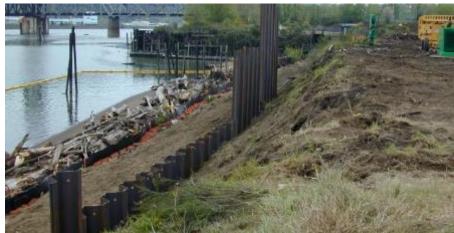
When Were External Sources Characterized and Addressed?

NAPL extraction alone was ineffective

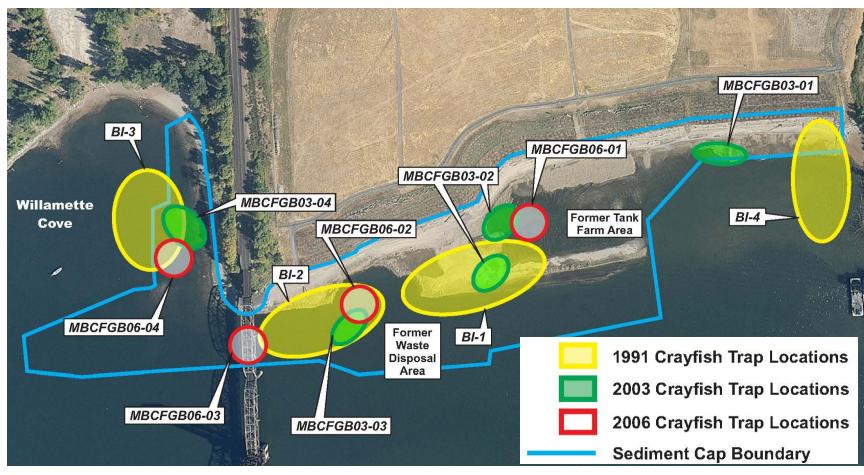
Primary Pre- and Post-Remedy Effectiveness Monitoring Elements

Surface Water Sample (~1' above cap surface) Articulated Concrete Block Rock Armoring (6 to 24 inches thick) Geotextile Filter Layer 3-inch minus Filter Rock (4 inches thick) (within armor layer) Sediment Sand Cap (2 to 5 feet thick, 1 foot thick Cap where organophilic clay was 2' to 5' Organophilic Clay (in areas where potential creosote seeps were identified, ~1 foot thick) Native (contaminated) Sediment

- Crayfish
- Dioxins/furans,
 PAHs, metals,
 and PCP
