Hudson River PCBs Superfund Site Case Study

U.S. EPA – Environmental Response Team

Upper Hudson Site Background

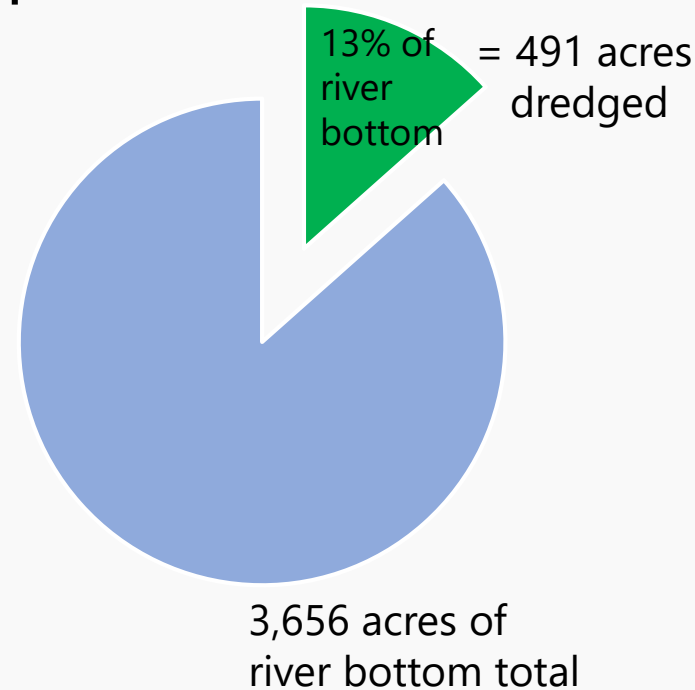
Spatial Extent of Remediation

Approximately 500 acres were dredged over a 40 mile stretch of the Upper Hudson between 2009 and 2015.

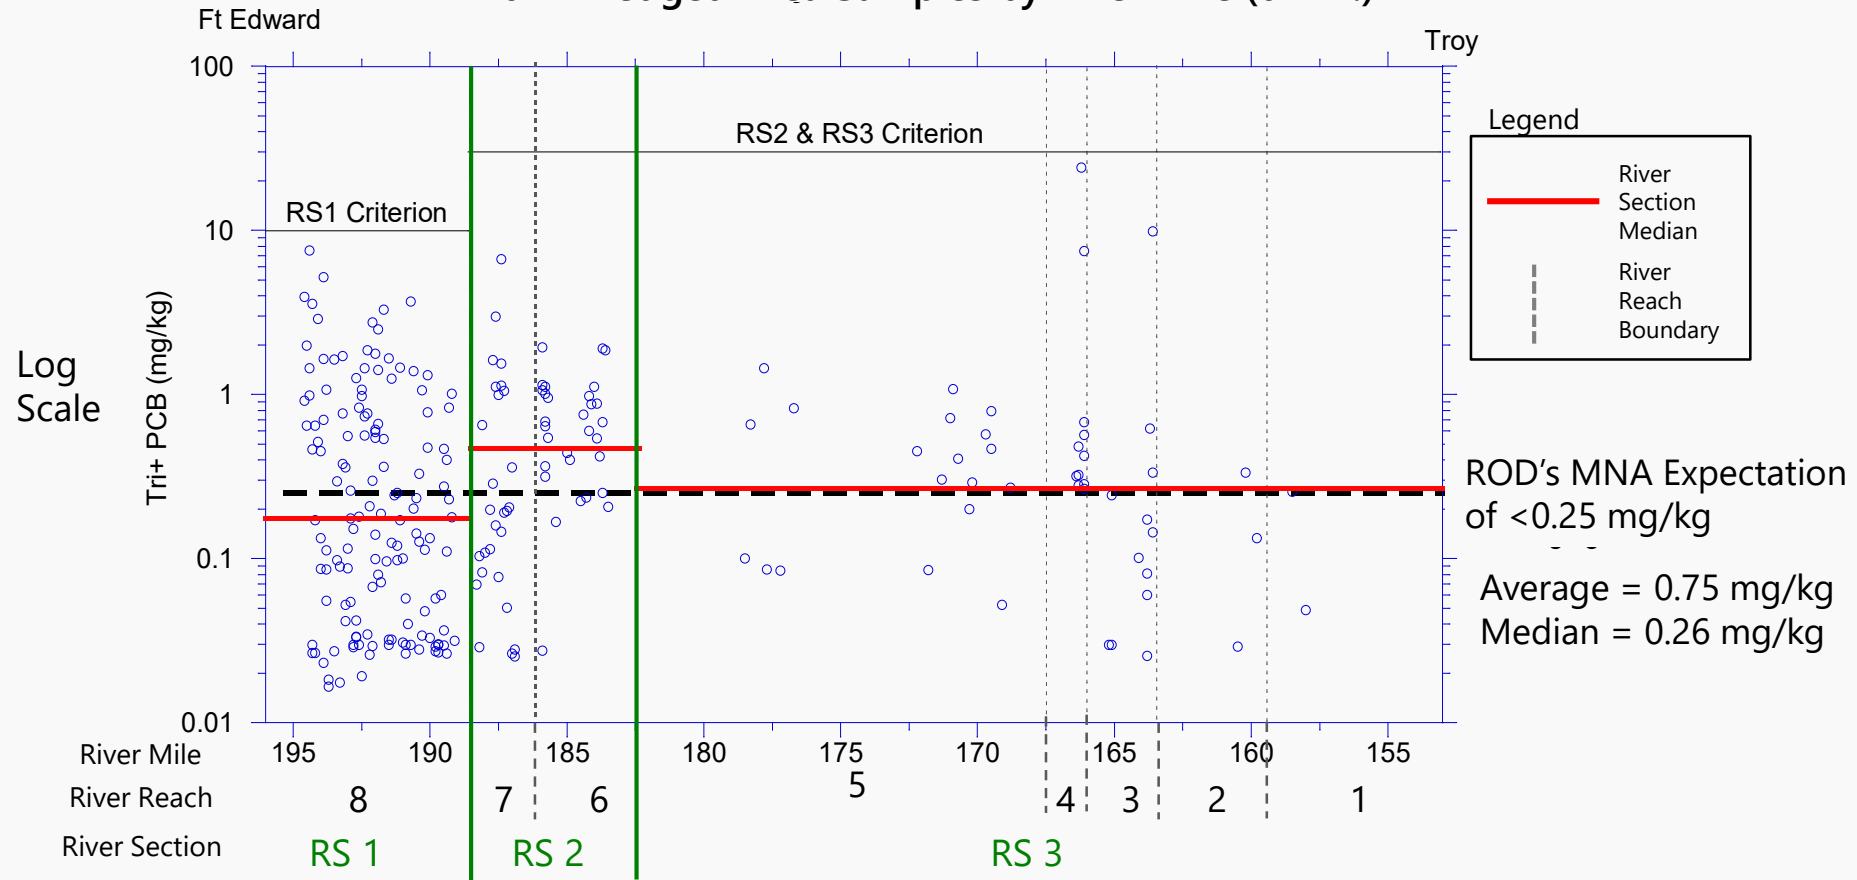
2017 Dredged Area Samples by River Mile (0-2in.)

Backfilled Areas Remain at Low Levels:

No evidence for substantive recontamination

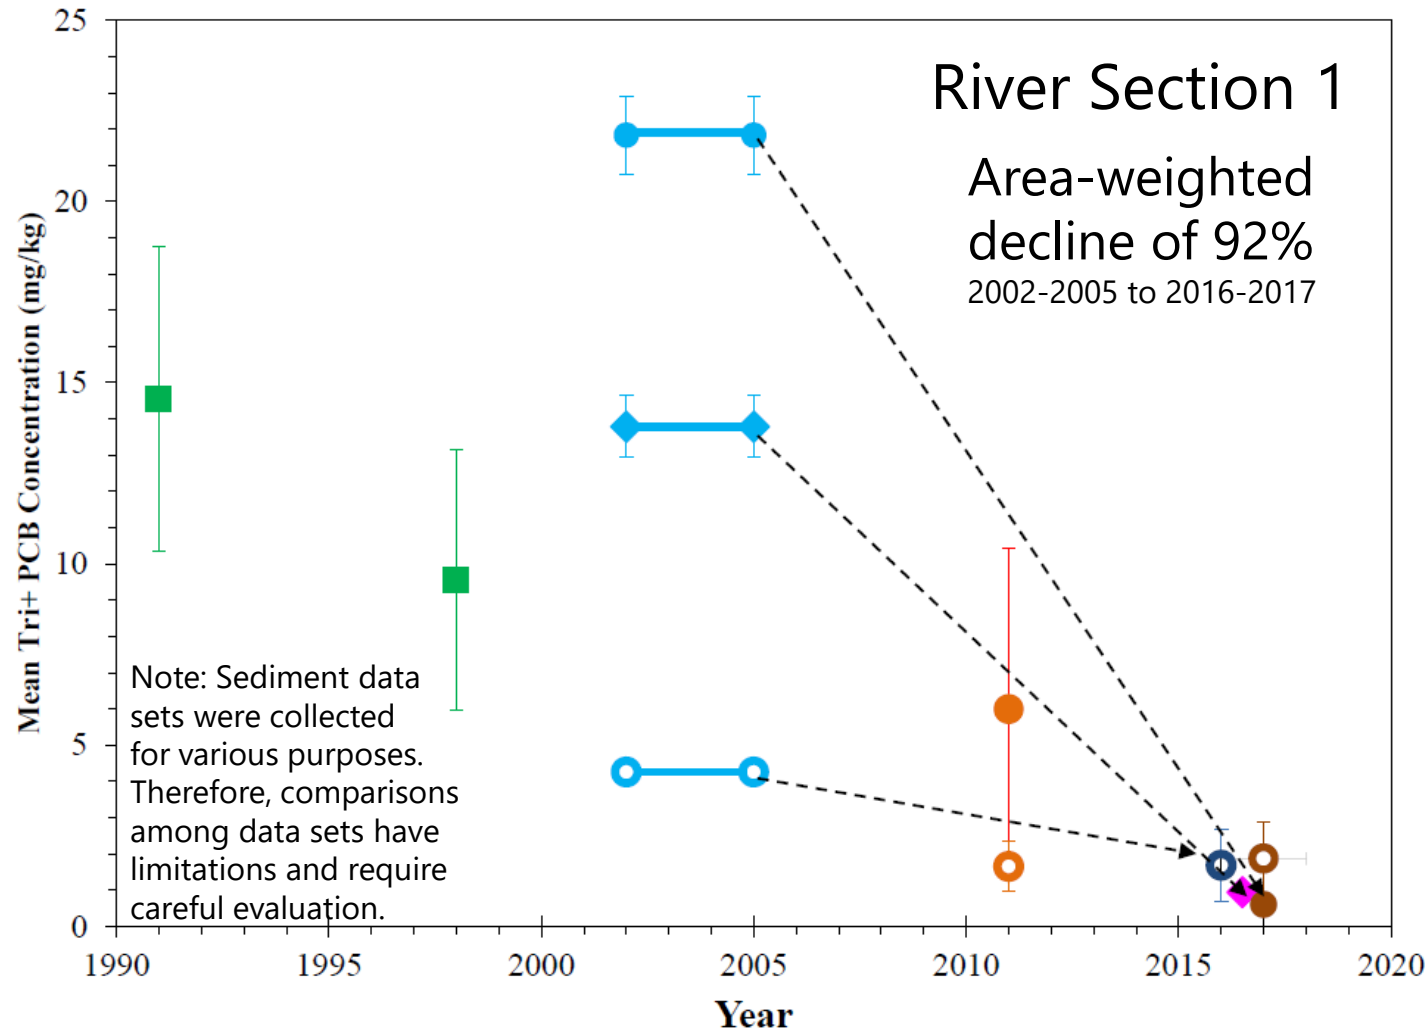
Data Document a Substantial Reduction in Surface PCB Concentration

- Dredged Area Average
- Non-Dredged Area Average
- Composite Sample Average
- ◆ Area-Weighted Average

- GE Composite Sample Surveys 1991 & 1998
- GE SSAP Program 2002-2005
- GE DDS Survey 2011
- GE OM&M Survey Non-Dredged Areas 2016
- NYSDEC Study 2017
- GE& NYSDEC Combined Surveys 2016 + 2017

Smaller but still substantive declines were observed in RS2 and RS3.

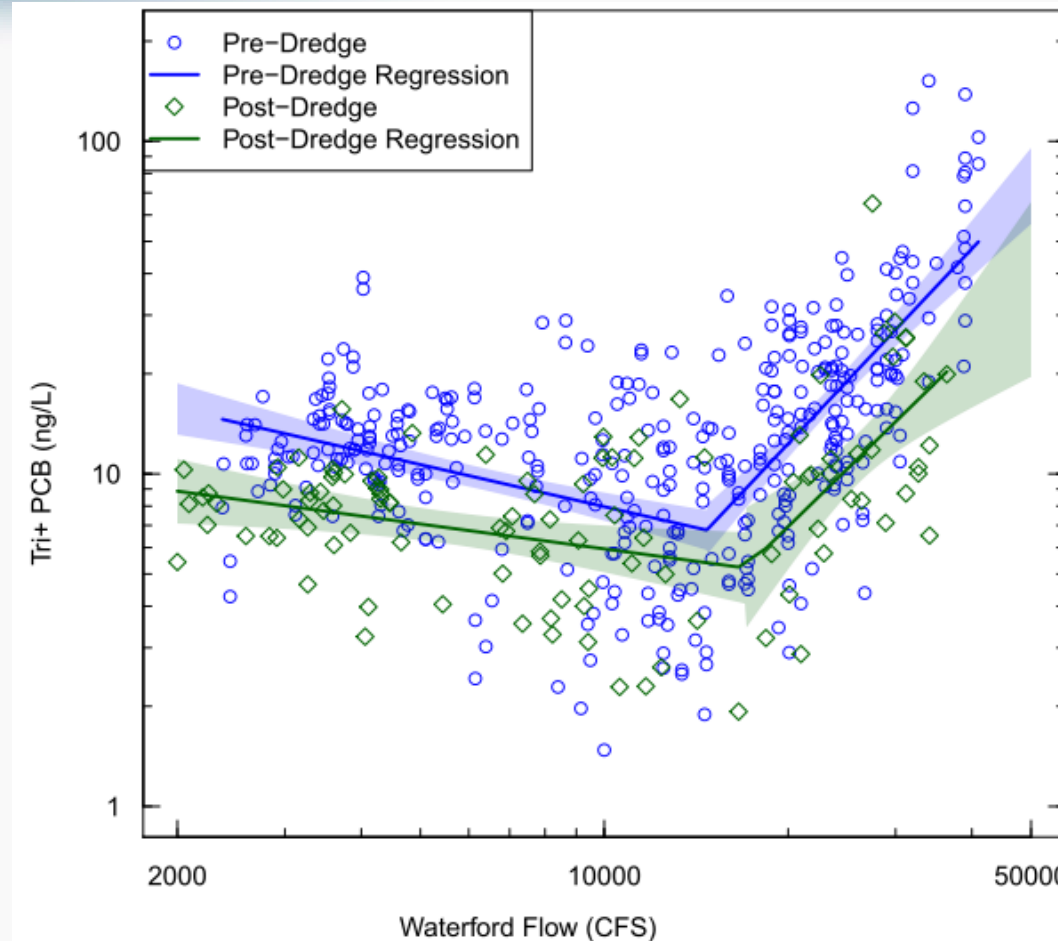
Decline in Water Column PCB Loads to Lower Hudson

Within 2 years of completion of dredging, PCB loads to the Lower Hudson have decreased between 30 and 50% relative to baseline.

Post-dredging PCB concentrations at Waterford have declined across all flow conditions

5. PCB loads to Lower Hudson have decreased from 30 to 50%, depending on flow.
6. Fish body burdens have declined from the dredging period maxima and are now at or below baseline conditions.
7. Year-to-year variations in fish body burdens indicate it is likely to require 8 or more years of monitoring to assess the actual post-dredging rate of recovery.
8. The impact of further Upper Hudson improvements on downstream conditions is unclear.

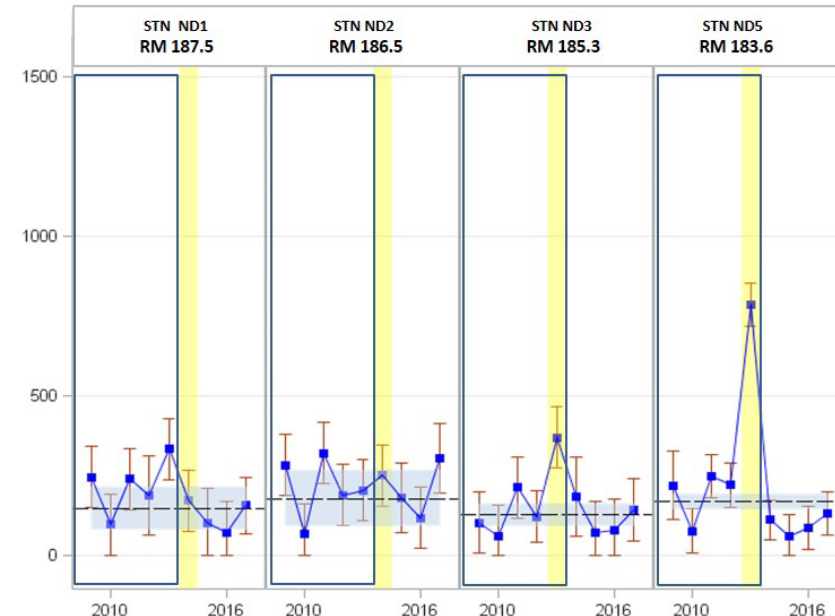
Reaches 7 and 8 (RS2) Pumpkinseed PCB Lipid Normalized (LPCB) Tissue Concentrations 2003-2017 (mg PCB/kg lipid) by Station and Year
