COMMENCEMENT BAY NEARSHORE/TIDEFLATS, WA

KRISTINE KOCH

U.S. ENVIRONMENTAL PROTECTION AGENCY, REGION 10

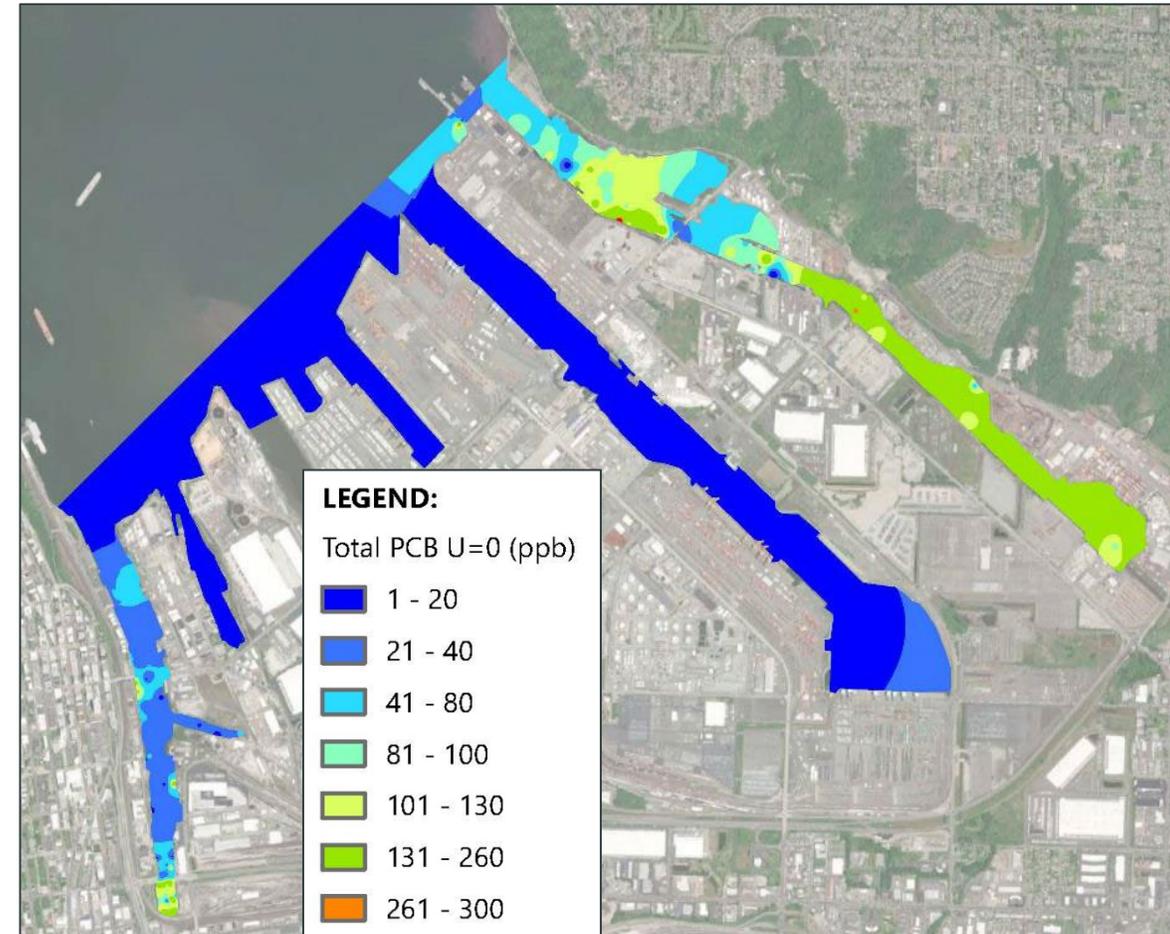
Surface Sediment Cleanup Levels Achieved

- Concentrations successfully reduced below cleanup levels
 - Benthic toxicity eliminated
 - Bioassay confirmation
 - PCBs < 300 ppb cleanup level
 - Localized exceedances of some CoCs:
 - Non-CERCLA diffuse stormwater sources
 - Slow under-pier natural recovery

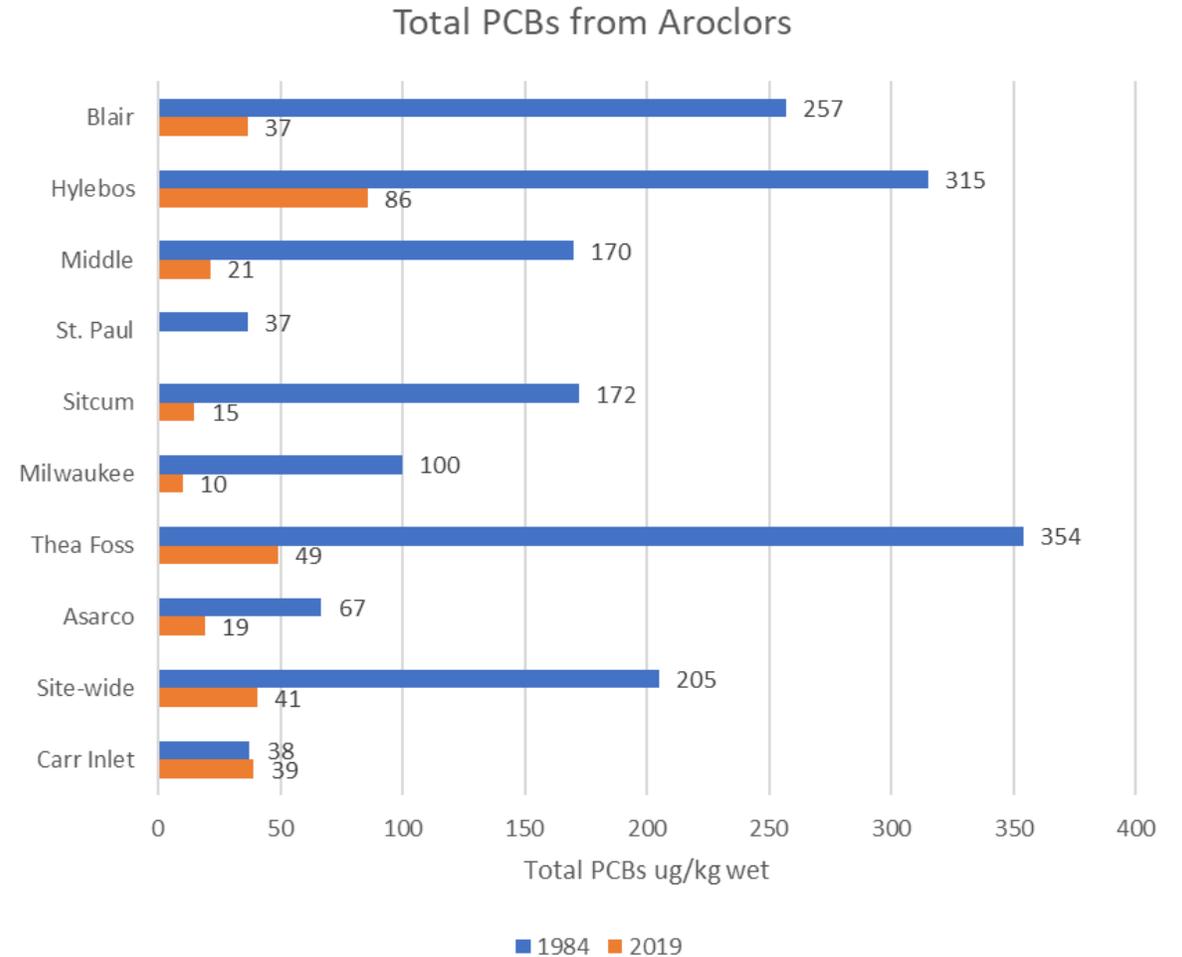
PCB Bioaccumulation Objectives Achieved

- RI sampling - 1984
- Post-remedy sampling - 2019
- Site-wide tissue conc. no different from reference (Carr Inlet)
 - 2-sample test; $p=0.05$
 - 80% lower than 1984 levels

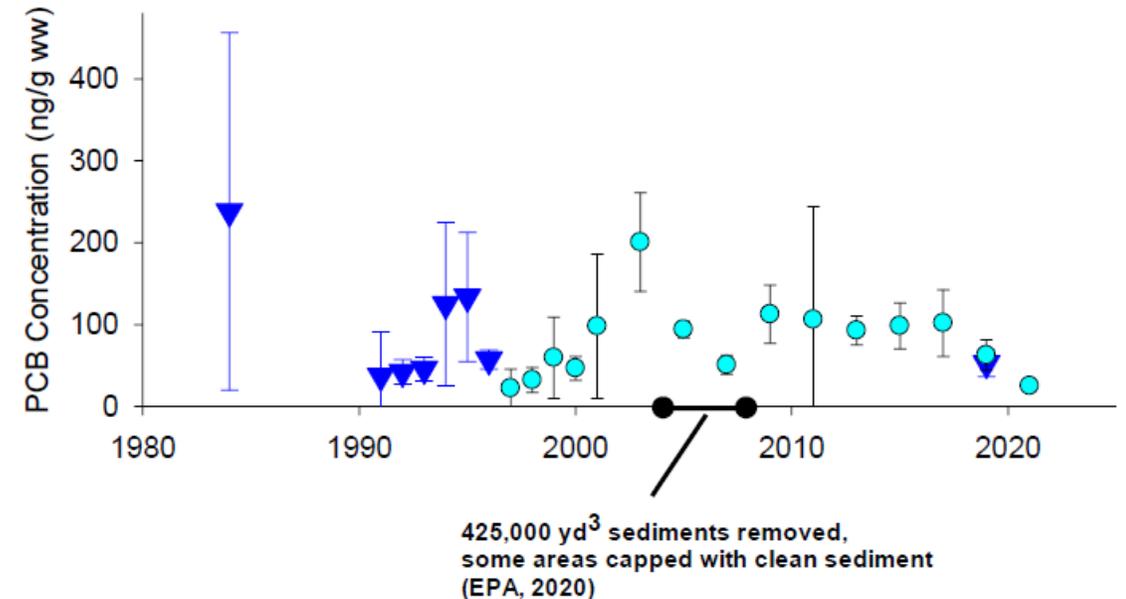
35-Yr Tissue PCB Trends: Mouth of Thea Foss Wtwy.

- Changes in analytical methods
- No long-term trend over 30 years
 - Uncertain sediment contribution to PCB bioaccumulation
 - No surface water data
 - Ongoing plankton research

Source: Washington State Department of Fish and Wildlife (2022)

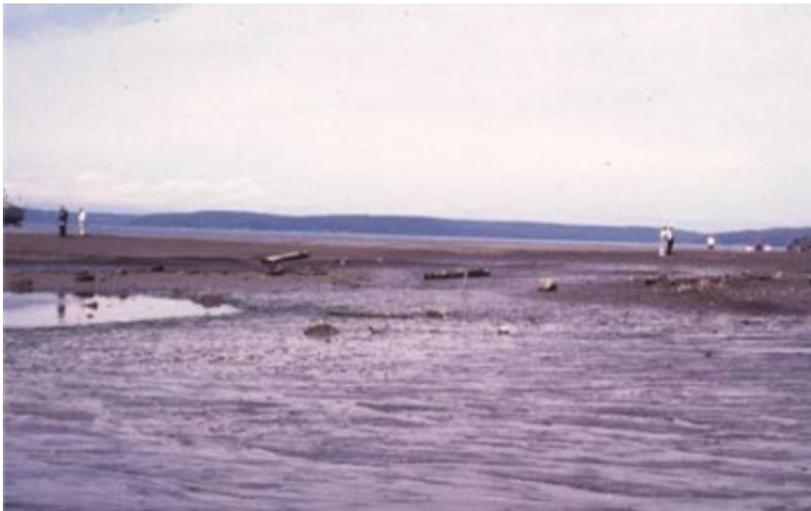
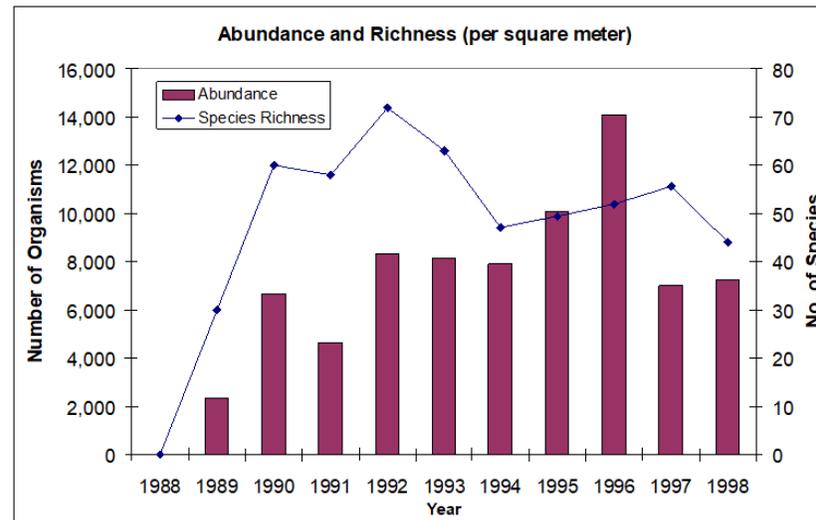
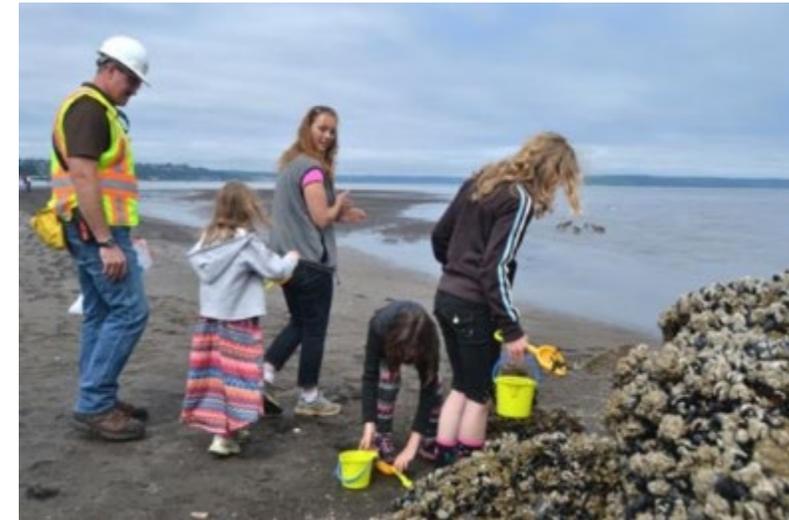
St. Paul Waterway Integrated Cleanup and NRD

- Remedial capping integrated with 20-acre intertidal beach restoration
 - 15-year post-construction monitoring: physical, chemical, and biological criteria
 - All cleanup and NRD restoration performance criteria achieved

Source: Parametrix 1999
