#### THE SOUTH RIVER MERCURY STORY

South River: CONCEPTUAL SITE MODEL SCHEMATIC **Pre-Remedy Inorganic Mercury loading to the South River** Overland Flow & Groundwater 5-20% **Factory Outfalls** Bedrock 3-5% Hg-Rich Layer **Bank Erosion** 40-60% Food web modeling indicates that Mercury in surface water is the dominant Sediment controlling factor 15-35% for transfer of Hg to biota

# EVALUATING EFFICACY OF PHASE 1 INTERIM MEASURES

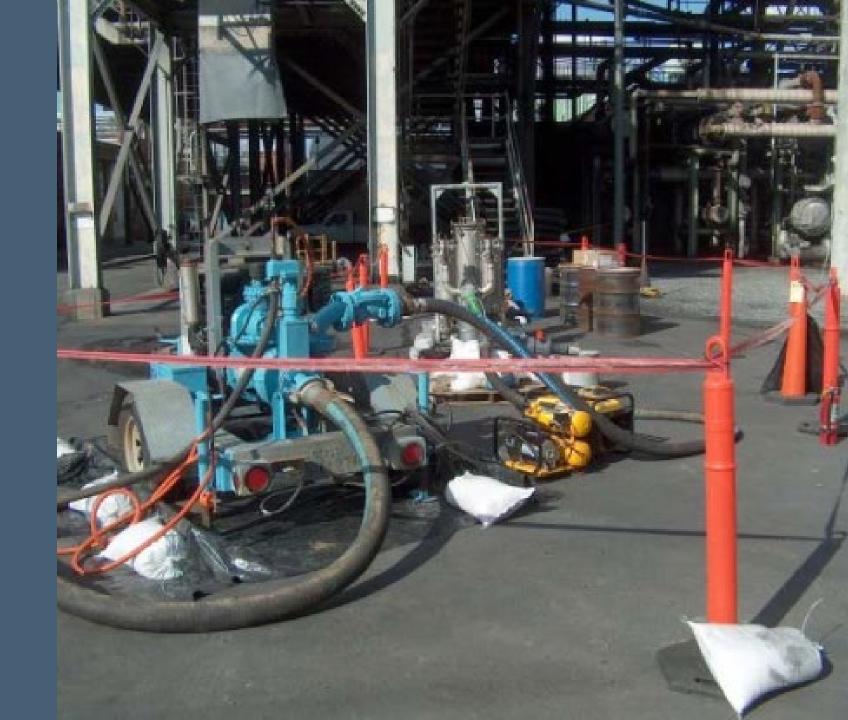
- Evaluation of other Potential Sources in the watershed was conducted early in the characterization 2001-2013
- Former Plant Site ~5% loading to river. Species of Hg potentially more bioavailable
  - Former Plant Site Remediation from 2010 to 2021
    - Removal
    - Capping
    - Sewer cleanout
